Wastewater System Facility Plan

Technical Draft

City of Troy

December 2023

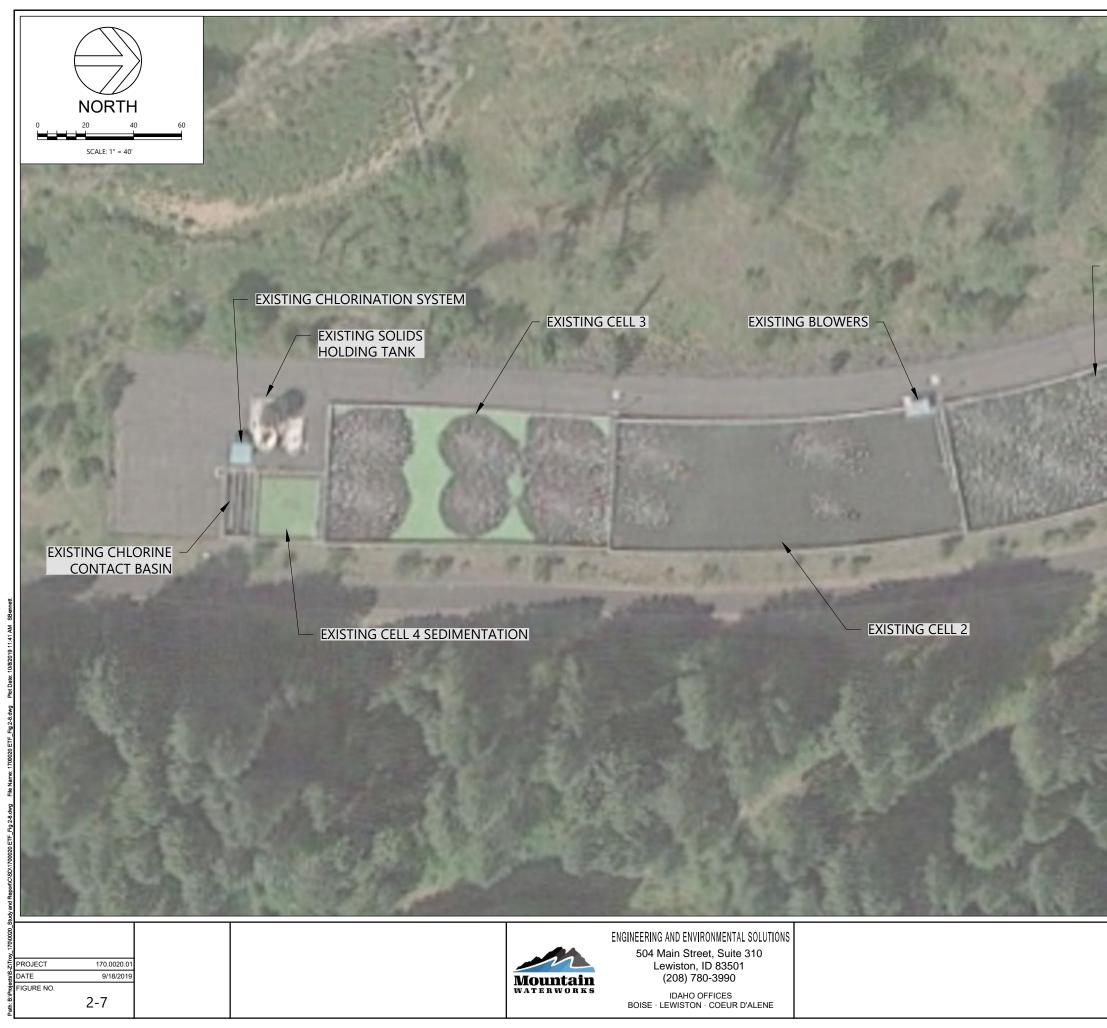
WASTEWATER FACILITY PLAN TROY, IDAHO EXISTING TREATMENT FACILITY

The treatment system utilizes three partially aerated lagoons followed by sedimentation and chlorine disinfection, as shown in **Figure 2-7**. Pretreatment is provided using a comminutor; the facility does not have screening or primary treatment facilities. Disinfection is provided using 12.5% sodium hypochlorite solution and a serpentine chlorine contact basin. The disinfected effluent is dechlorinated using calcium thiosulfate prior to discharge. A submersible pump station containing two submersible pumps is used to return mixed liquor from the sedimentation basin to the head of the plant. The pumps also have the capability to remove some solids from the treatment process; however, this process is not routinely employed. Solids typically settle out in all three of the lagoon cells and must be periodically removed to restore treatment capacity. A solids removal and land application project was completed in 2020 that saw removal and subsurface injection on farm ground of 155 dry tons of solids removed from lagoon Cells 1 and 2. **Photos 2-1** and **2-2** show Cell 1 solids content before and after the project, respectively.

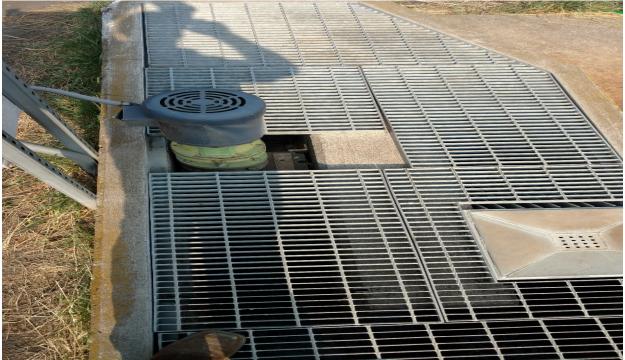
Photo 2-3: Pretreatment with Electric Comminutor and Manual Bar Rack

The comminutor reduces the size of unwanted plastics, rags, and other trash contained in the raw wastewater, lessening the likelihood it will clog or block downstream pumps, pipes, or other equipment. Plastics and trash tend to catch in the sedimentation basin overflow weir, foul the chlorine contact basin, and settle out in the solids in the lagoon cells. The presence of the trash increases cleaning and equipment maintenance requirements and contaminates the solids, which can limit disposal options. Landowners or compost facility operators will typically not accept unscreened solids contaminated with plastics and trash.

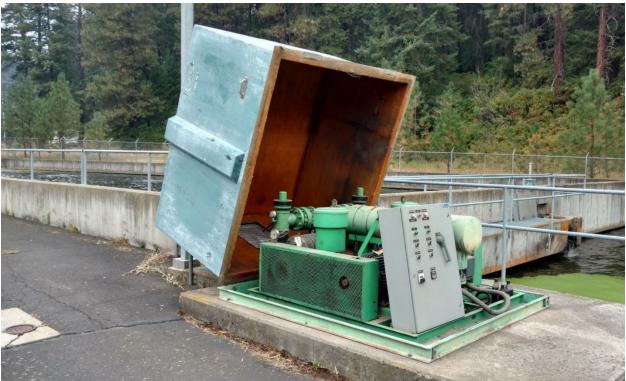
Photo 2-4: Aeration System Blowers

During normal operation, only one blower operates at time and a 24-hour timer alternates the active blower to equalize runtime between the two units. A temperature switch is provided to shut down a blower if its temperature exceeds 250°F.

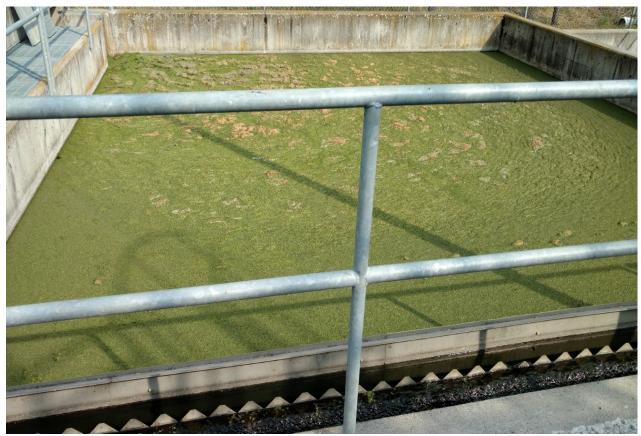
Photo 2-5: Cell 4 During Summer

- Algae and duckweed are present near the water surface in Cell 3 and Cell 4 where sunlight
 is sufficient to facilitate plant growth (Photo 2-5). Withdrawing effluent via the overflow
 weir from Cell 3 transfers algae and duckweed into Cell 4, where it accumulates on the
 surface. This condition could be mitigated by using the lower inlet pipe. The presence of
 algae and duckweed in the Cell 4 effluent causes higher TSS, increases chlorine demand,
 and increases the potential for *E. coli* exceedances.

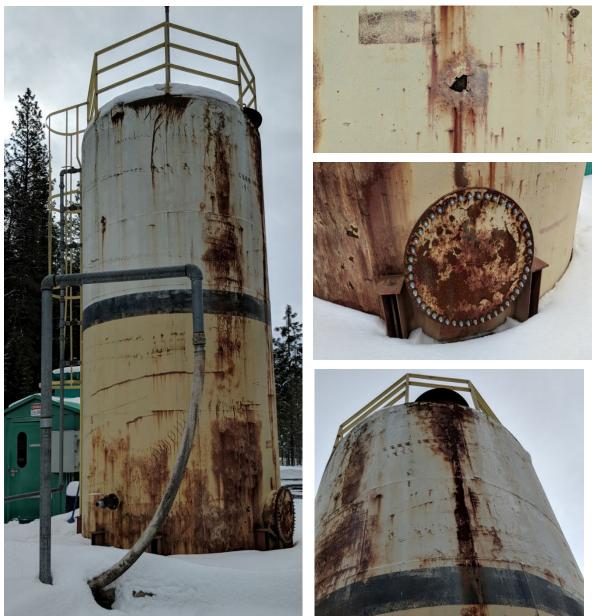
Photo 2-6: Aerated Sludge Holding Tank

Solids removed using the solids pump station can be discharged to the welded steel holding tank. The tank is approximately 20 feet tall, 9 feet in diameter, and provides 9,500 gallons of storage. It is equipped with a 5 horsepower (hp) positive displacement blower that supplies air to two diffusers located 6 inches from the bottom to aerate and mix the solids and prevent septic conditions from developing. The tank has decanting ports along one side that allow solids to settle and thicken while supernatant is discharged through a temporary connection to the solids pump station.

The solids storage system was installed in 2001 to provide additional flexibility in gathering, thickening, and wasting solids from the treatment process. However, the tank coatings have not been maintained and the tank is in poor condition; the shell has extensive corrosion damage (**Photo 2-6**). The tank is not used due to the lack of a headworks and raw influent screening to remove trash and plastics that plug the discharge port. Based on interviews with operations staff, the tank has only been used once since it was installed.

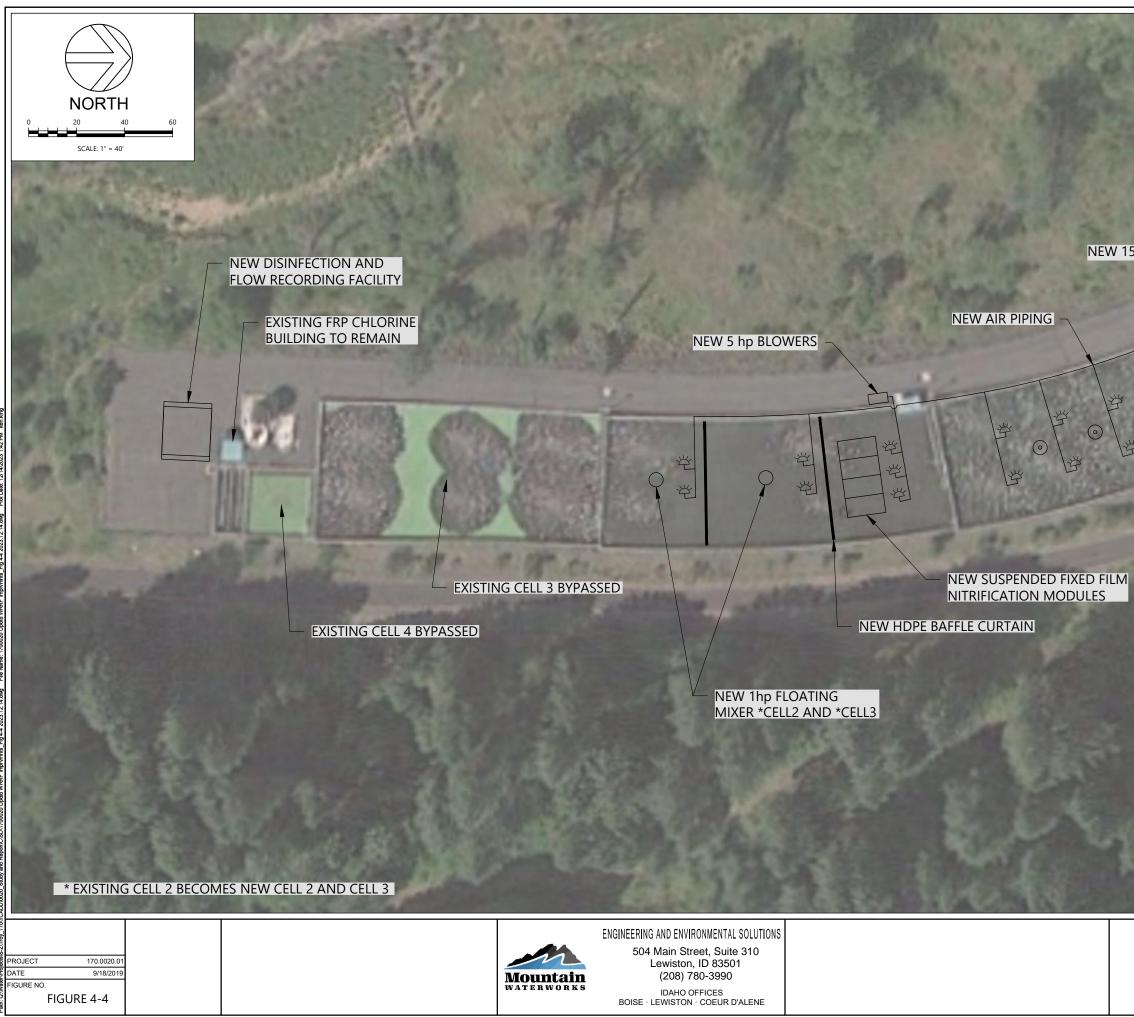
NEW 15 hp BLOWERS

NEW HEADWORKS

- Construct new disinfection facility to house chlorination/dechlorination and effluent flow measurement equipment. Remove disinfection equipment from existing building.

In addition to biological treatment, the purpose of this alternative is to lessen the negative impacts of algae production on disinfection and provide an environment conducive to concentrating solids where they can decompose (Cell 2). By concentrating solids in Cell 2, future sludge removal efforts can be better predicted and managed. Furthermore, by lessening HRT heat in the process can be better retained and nitrification efforts will be more successful. **Section 5** details the breakout of selected portions in this alternative. **Figure 4-4** presents the components of this alternative superimposed over the existing treatment facility. Note that Alternative TF-1 would be included with Alternative TF-2.

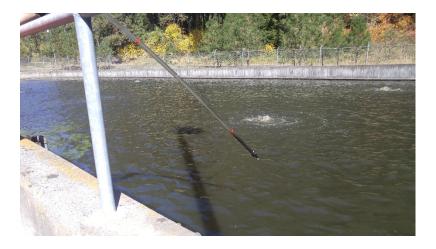
The total depth of water and sludge in the treatment cells is approximately 10 feet. Sludge samples were drawn from various locations within the three treatment cells. Sample results indicate a sludge layer approximately 8-inches to 16-inches in depth, with an average of approximately 12 inches, is contained within the treatment facility. Operating the facility with an average sludge depth of 12 inches is within normal operation conditions. A photo of the sampling is shown below.
